UNDERWATER BRIDGE INSPECTION REPORT

STRUCTURE NO. 24506

SHELL ROCK RIVER

DISTRICT 6 - FREEBORN COUNTY, CITY OF ALBERT LEA

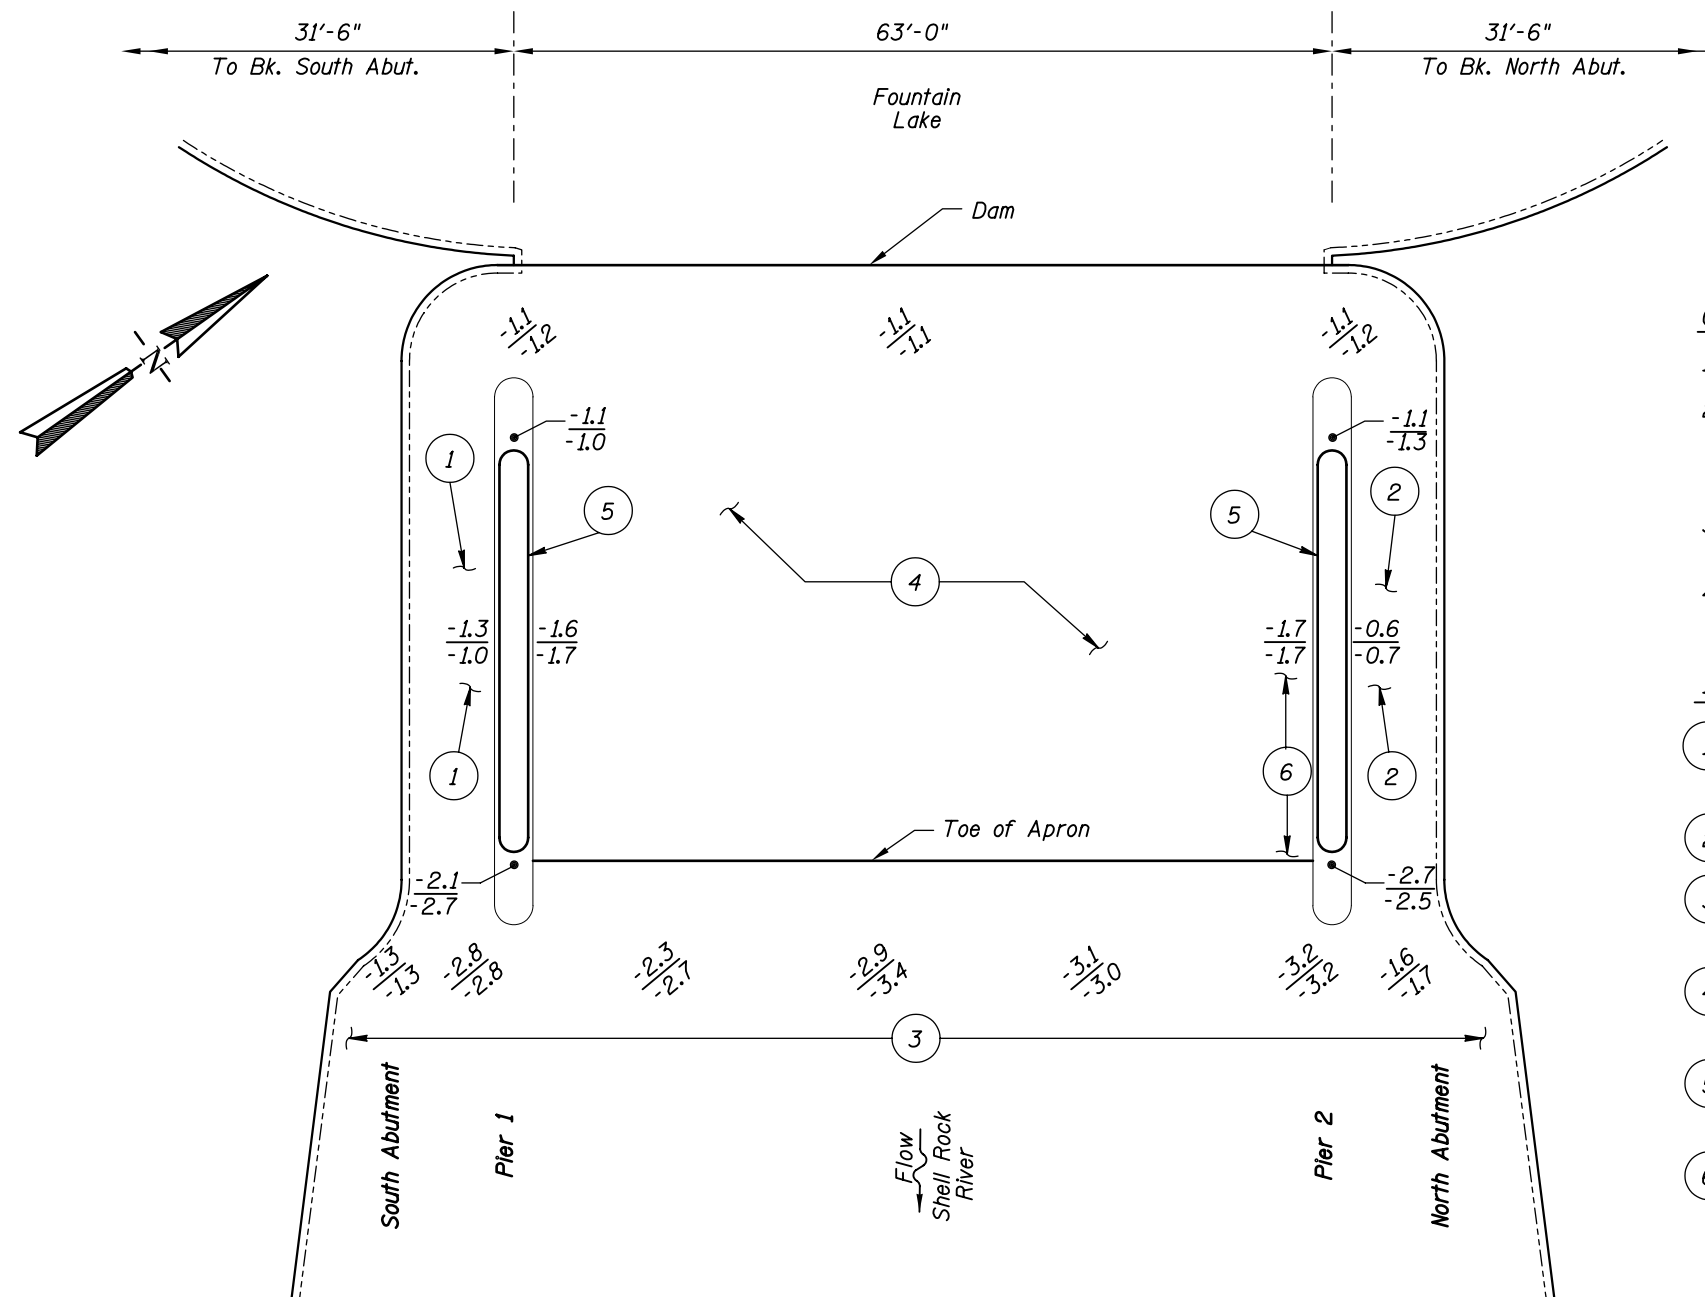
INSPECTION AND SOUNDING PLAN

- The channel bottom material consisted of sand and gravel with random riprap up to 1 foot in diameter.
- The channel bottom material consisted of sandy gravel.
- The channel bottom material consisted of silty gravel with scattered cobbles at the end of the concrete apron.
- The channel bottom consisted of a concrete apron. The apron was in good condition with no undermining observed.
- Random light scaling was observed near the waterline on both piers. The channel bottom typically allowed up to of probe rod penetration.
- The concrete apron exhibited an area of poorly formed concrete with exposed reinforcing near the downstream end of Pier 2.

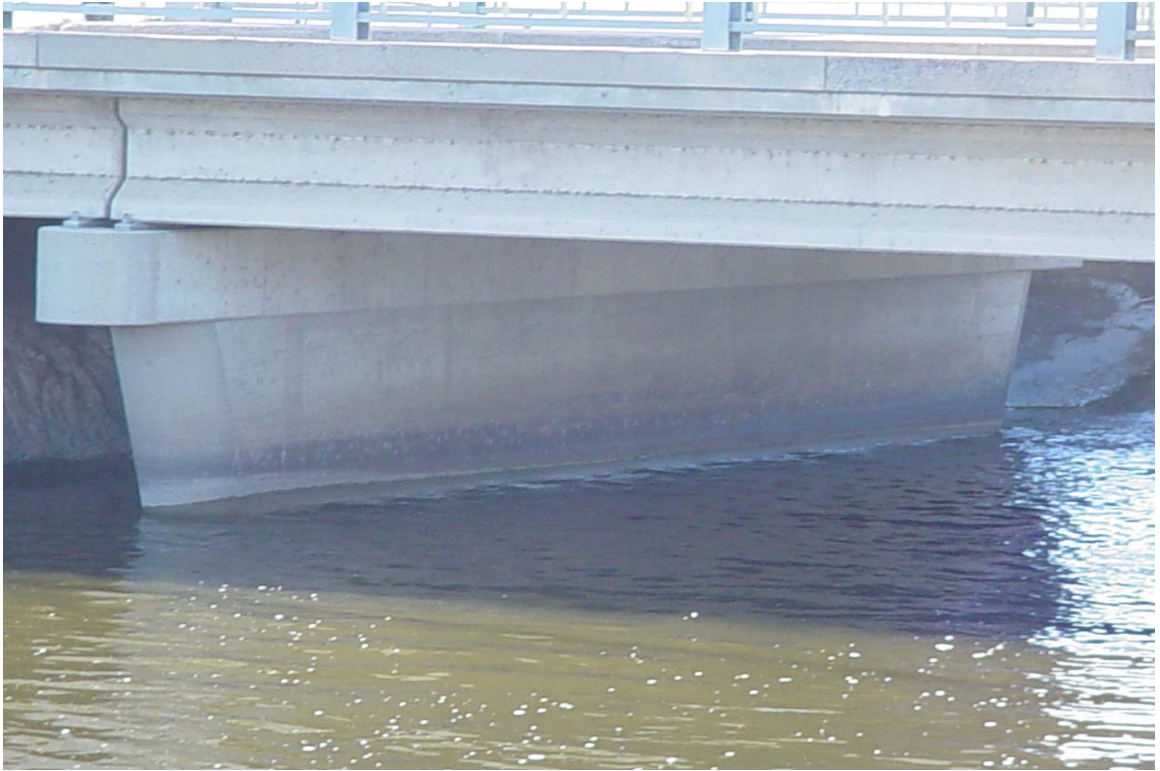
Photograph 1. View of Pier 1, Looking West.

- (A) The concrete of the piers was in good condition with random areas of light scaling observed near the waterline.
- (B) An area of poorly formed concrete with exposed reinforcing steel was observed on the concrete apron near the downstream end of Pier 2.

- (A) Reinspect the submerged substructure units at the normal maximum recommended (NBIS) interval of five (5) years.
